ARCHITECT'S FIELD REPORT**08**

PROJECT	Village Center Remodel Emmons Building, 600 Gothic Road Axtell Building, 22 Snowmass Road	DATE	10/1/19
----------------	--	-------------	---------

WORK OBSERVED	
Specialty Concrete Repair, Metal Wainscot Installation	
TRADES PRESENT	
Pinnacle Inc.

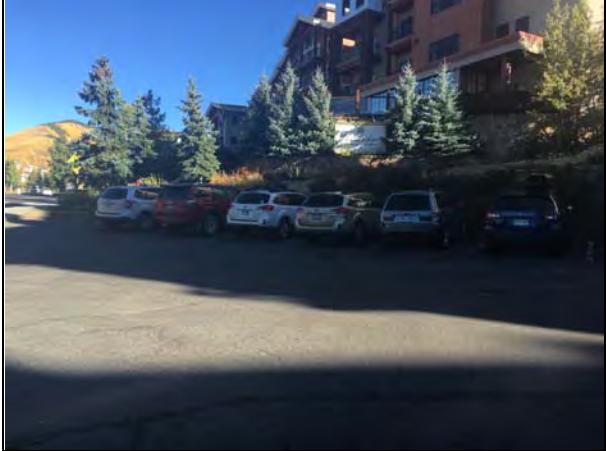
<p>10/1/19 – Photo 1 Emmons Building</p> <p>Parking lot looking north.</p>	Note
 	<p>10/1/19 – Photo 2 Emmons Building</p> <p>Parking lot looking west.</p>	Note
 	<p>10/1/19 – Photo 3 Emmons Building</p> <p>Parking lot looking west. Dumpster trailer is on site.</p>	Note

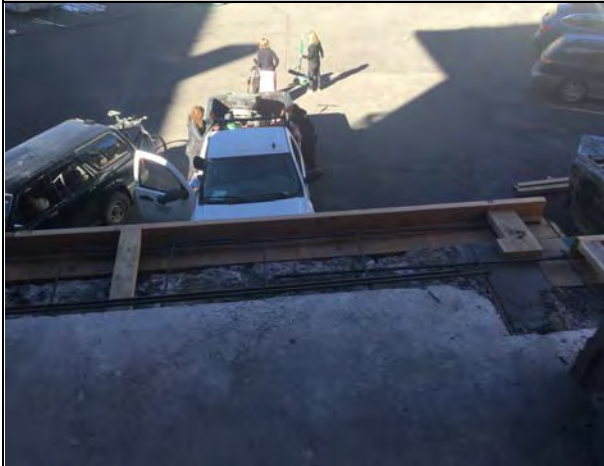
<p>10/1/19 – Photo 16 Emmons Building</p> <p>Detail of the formwork.</p>	<p>Note</p>

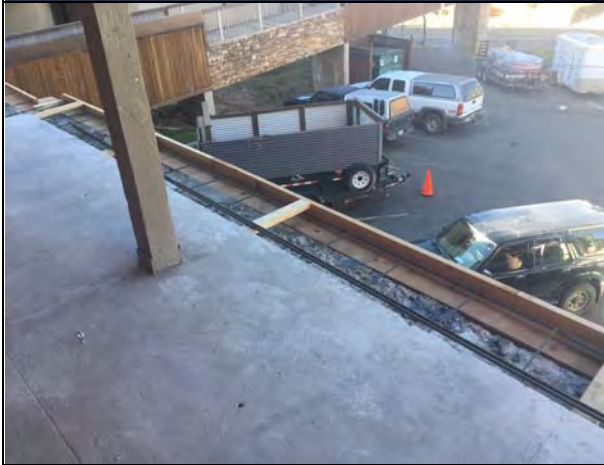
<p>10/1/19 – Photo 17 Emmons Building</p> <p>Detail of the formwork.</p>	<p>Note</p>

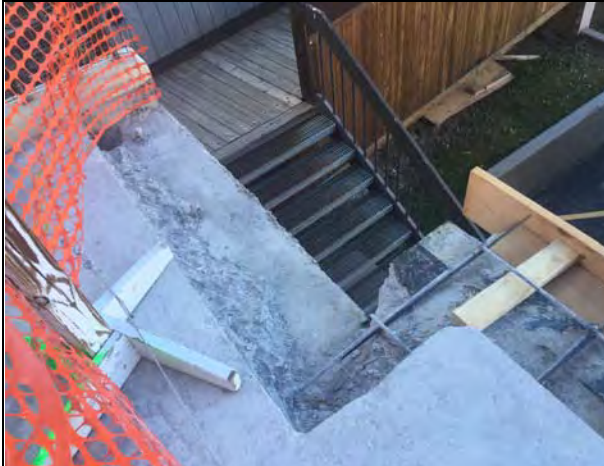
<p>10/1/19 – Photo 18 Emmons Building</p> <p>Detail of the formwork and rebar at the south corner.</p>	<p>Note</p>

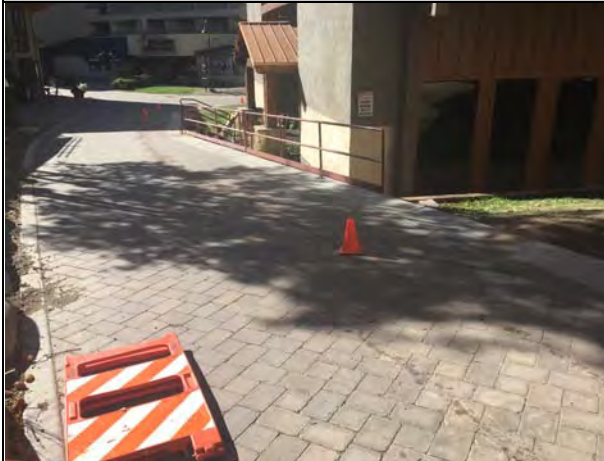
<p>10/1/19 – Photo 19 Emmons Building</p> <p>East sidewalk. Hydraulic oil from the United Lift tracks the full length of the sidewalk.</p>	PI

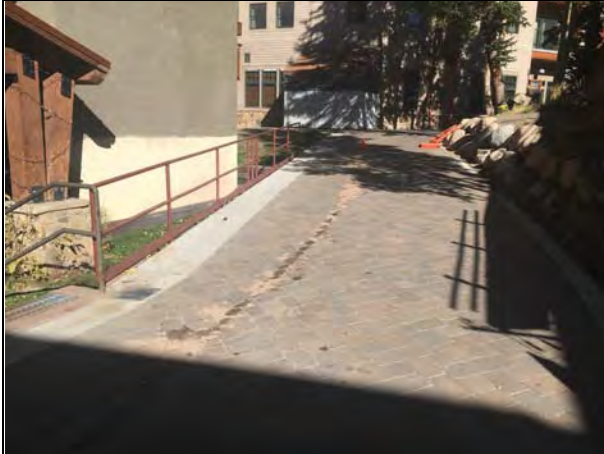
<p>10/1/19 – Photo 20 Emmons Building</p> <p>East sidewalk. Hydraulic oil from the United Lift tracks the full length of the sidewalk.</p>	PI

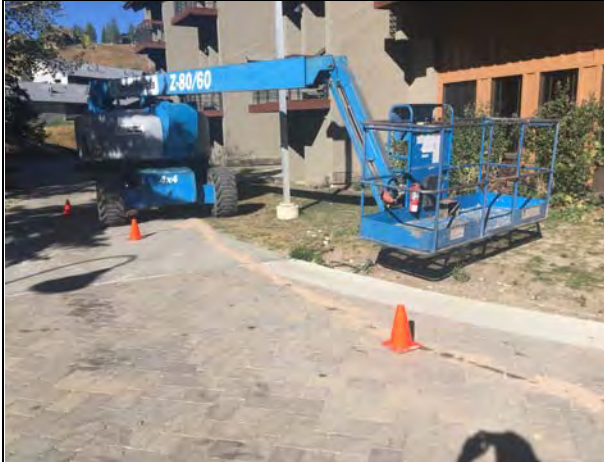
<p>10/1/19 – Photo 21 Emmons Building</p> <p>South sidewalk. Hydraulic oil tracks to the lift. Sand/gravel has been applied.</p> <p>Clean up efforts to be coordinated.</p>	PI
