**ARCHITECT'S FIELD REPORT****12**

<b>PROJECT</b>	<b>Village Center Remodel</b> Emmons Building, 600 Gothic Road Axtell Building, 22 Snowmass Road	<b>DATE</b>	11/1/19
----------------	--	-------------	---------

## Engineer's field report

Project: Village Center Remodel  
Date: 10/28/19

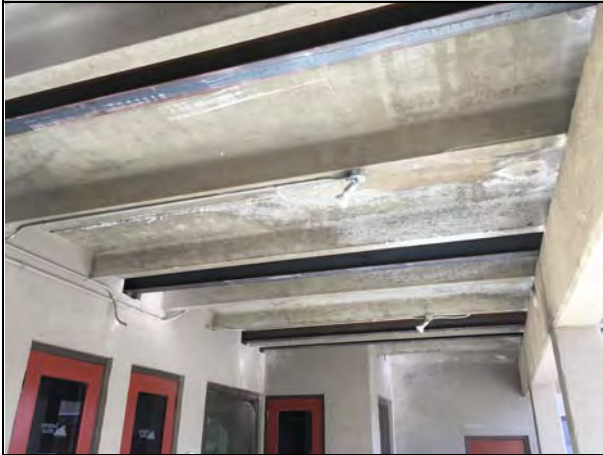
<p>10/31/19 – Photo 4 Emmons Building</p> <p>West 1<sup>st</sup> floor entrance. Steel reinforcing beams are in place.</p>	Note

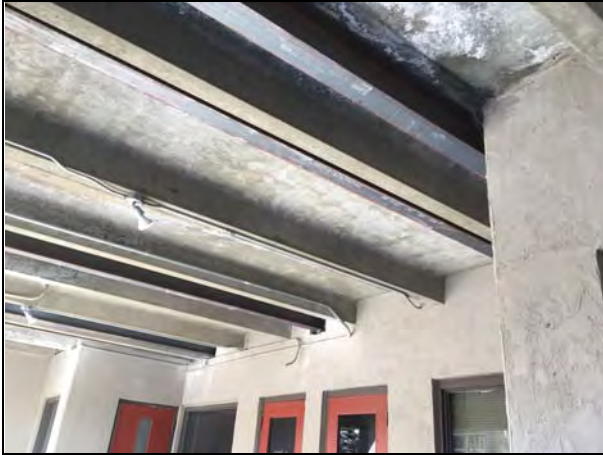
<p>10/31/19 – Photo 5 Emmons Building</p> <p>West 1<sup>st</sup> floor entrance. Steel reinforcing beams are in place.</p>	Note

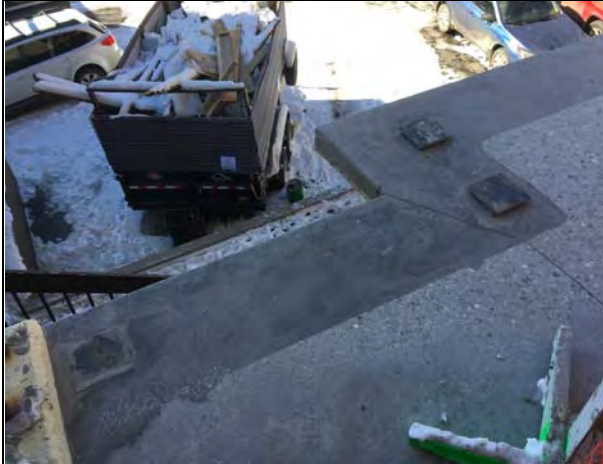
<p>10/31/19 – Photo 6 Emmons Building</p> <p>2<sup>nd</sup> Floor Plaza Deck edge has been poured and ground flat.</p>	Note

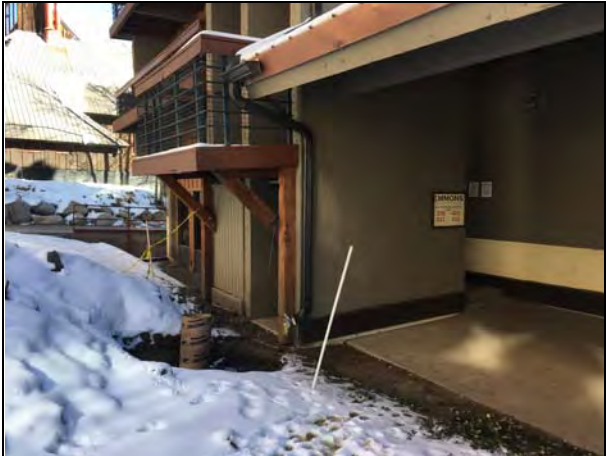
<p>10/31/19 – Photo 16 Emmons Building</p> <p>Northeast corner downspout condition. Note that downspout has been extended now that the north canopy will remain.</p>	<p>Note</p>

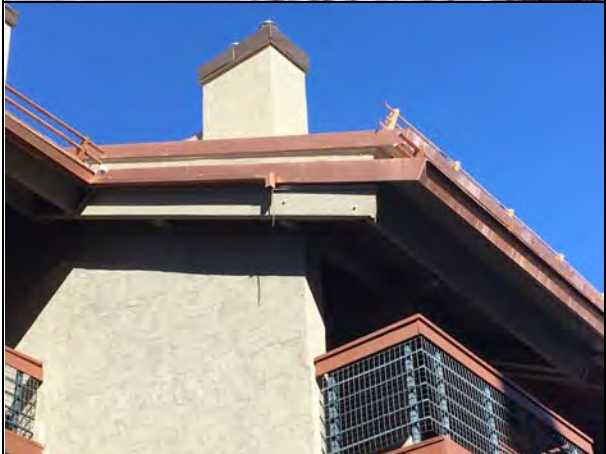
<p>10/31/19 – Photo 17 Emmons Building</p> <p>Awaiting south gutter extension.</p>	<p>Note</p>

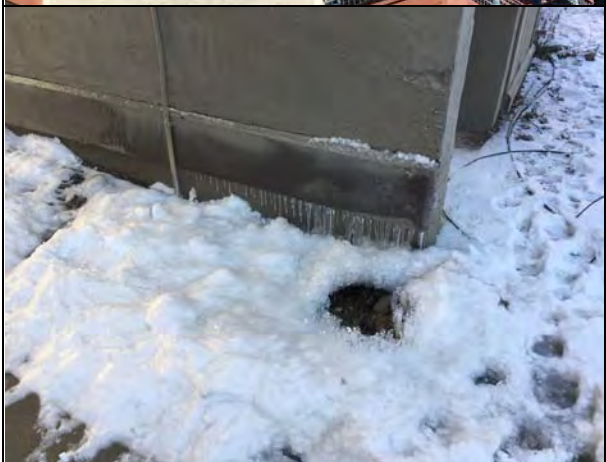
<p>10/31/19 – Photo 18 Emmons Building</p> <p>South gutter discharges water at the base of the stairwell. This condition will be remedied by extending the gutter farther down the eave.</p>	<p>CBL</p>

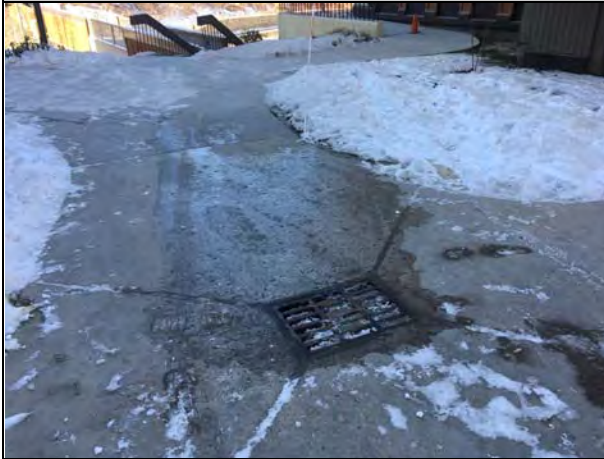
<p>10/31/19 – Photo 19 Emmons Building</p> <p>South area drain. Drain currently freezes and backs up. CBL recommended heat tape to remedy the condition.</p>	CBL

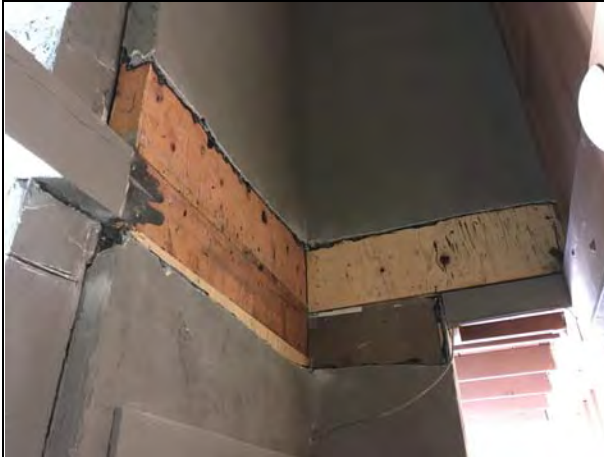
<p>10/31/19 – Photo 20 Emmons Building</p> <p>Stairwell #1, 4<sup>th</sup> Floor structural repairs.</p>	Note

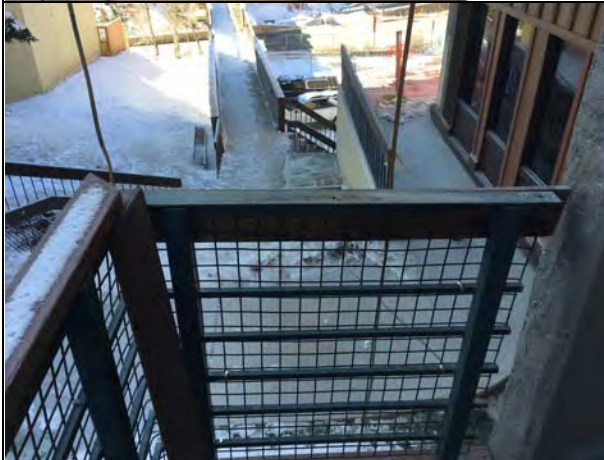
<p>10/31/19 – Photo 21 Emmons Building</p> <p>Stairwell #5, guardrail top has been removed.</p>	PI

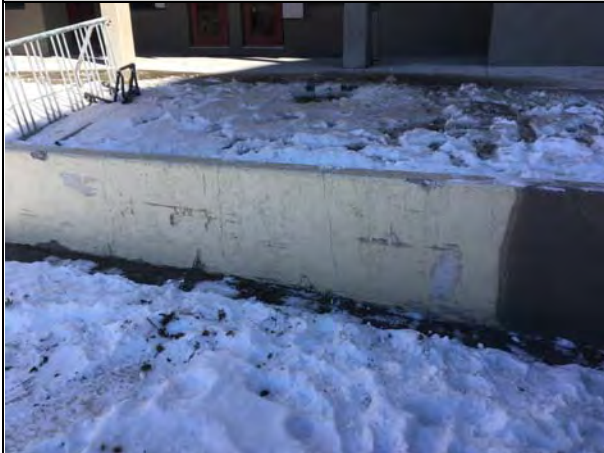
<p>10/31/19 – Photo 22 Emmons Building</p> <p>West site retaining wall has not been completed.</p>	AAS

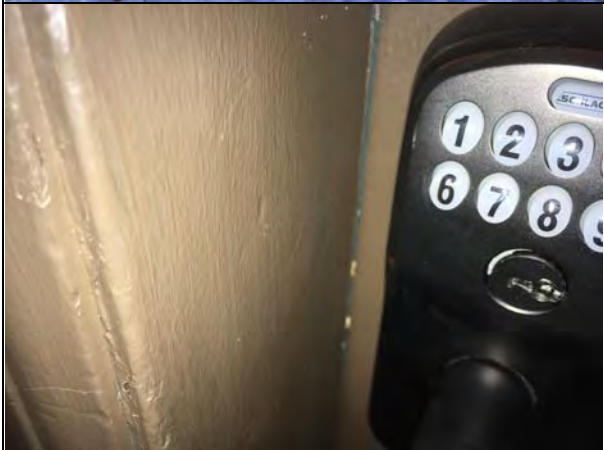
<p>10/31/19 – Photo 23 Emmons Building</p> <p>Unit 320 door perimeter has not been painted.</p>	AAS

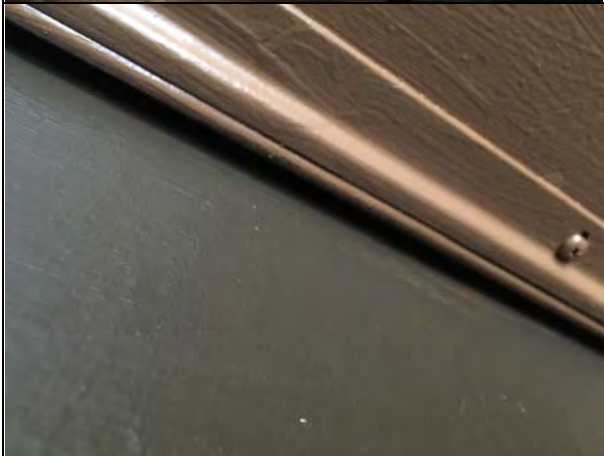
<p>10/31/19 – Photo 24 Emmons Building</p> <p>Unit 324 door perimeter has not been painted. (Not clearly depicted in this photo.)</p>	AAS

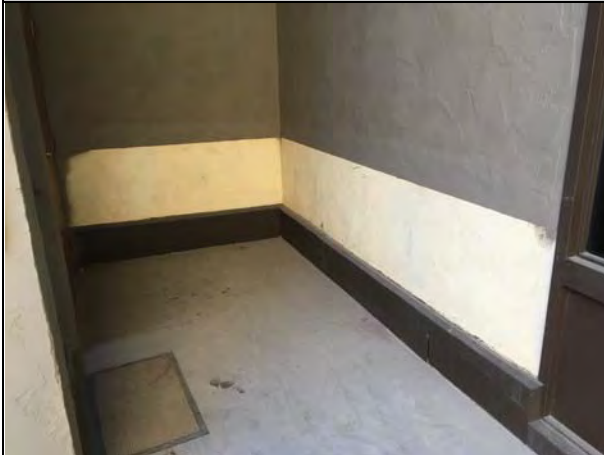
<p>10/31/19 – Photo 25 Emmons Building</p> <p>Paint has been applied to the top line of the metal wainscot.</p>	Note

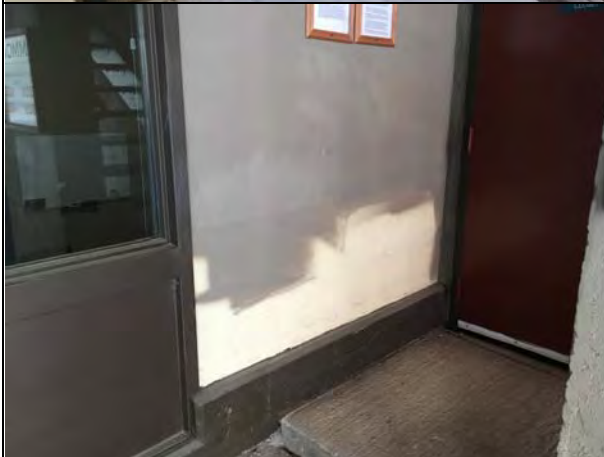
<p>10/31/19 – Photo 26 Emmons Building</p> <p>Paint has been applied to the top line of the metal wainscot.</p>	Note

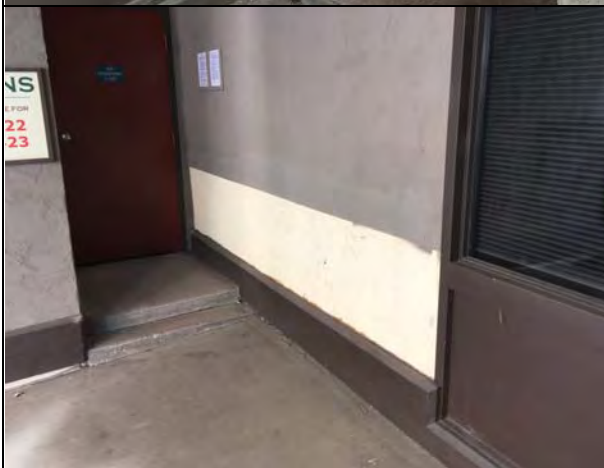
<p>10/31/19 – Photo 27 Emmons Building</p> <p>Paint has been applied to the top line of the metal wainscot.</p>	Note

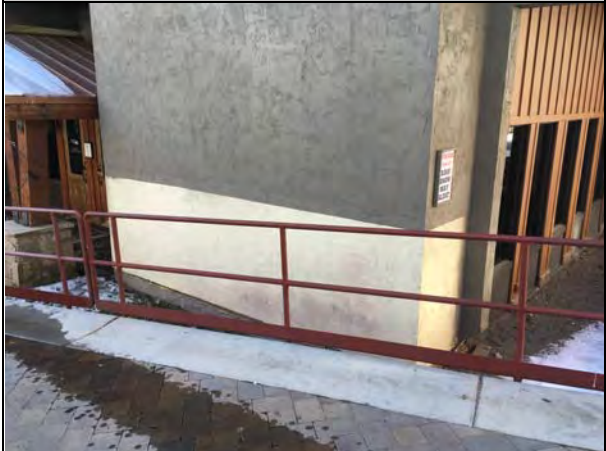
<p>10/31/19 – Photo 28 Emmons Building</p> <p>Paint extended to the top line of the metal wainscot.</p>	Note

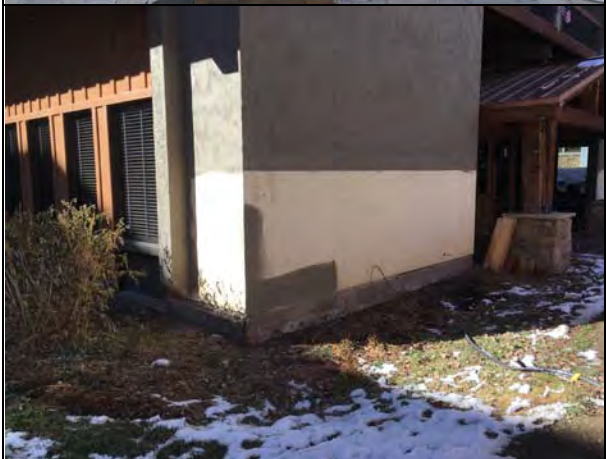
<p>10/31/19 – Photo 29 Emmons Building</p> <p>Paint has been applied to the top line of the metal wainscot.</p>	Note

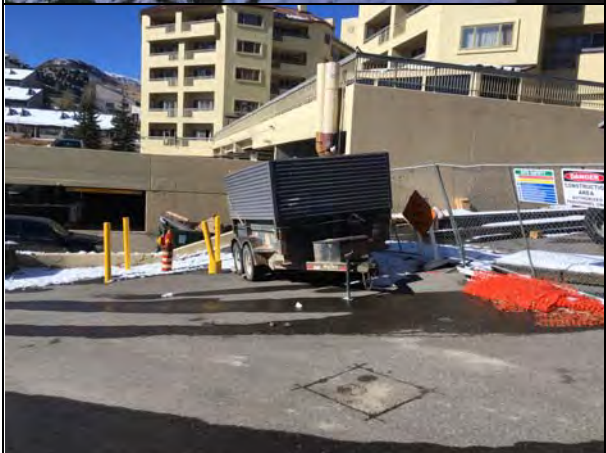
<p>10/31/19 – Photo 30 Axtell Building</p> <p>Construction dumpster.</p>	Note

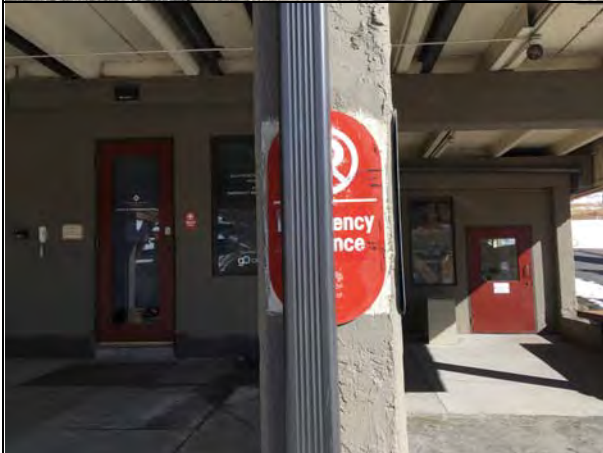
<p>10/31/19 – Photo 36 Axtell Building</p> <p>Sign will need to be relocated relative to the downspout.</p>	Note

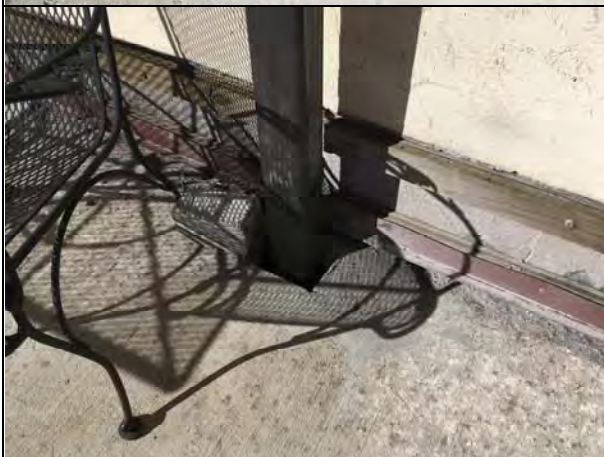
<p>10/31/19 – Photo 39 Axtell Building</p> <p>Downspout extended through the plaza deck.</p>	Note

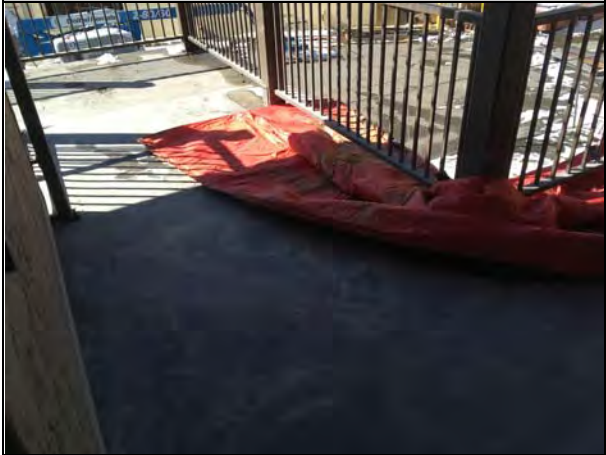
<p>10/31/19 – Photo 40 Axtell Building</p> <p>West plaza deck repairs. Repaired surface has been ground flat.</p>	Note

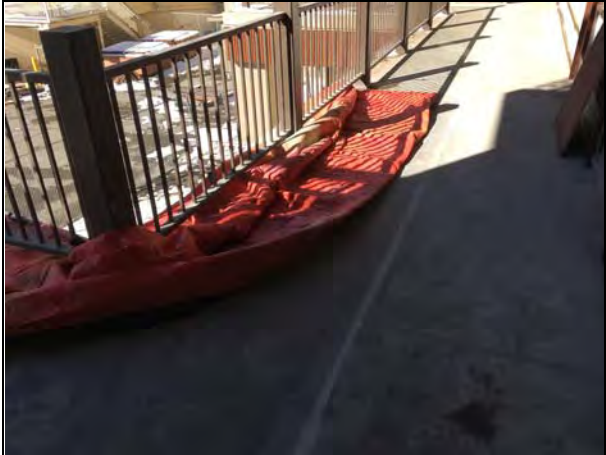
<p>10/31/19 – Photo 41 Axtell Building</p> <p>West plaza deck repairs. Repaired surface has been ground flat.</p>	Note

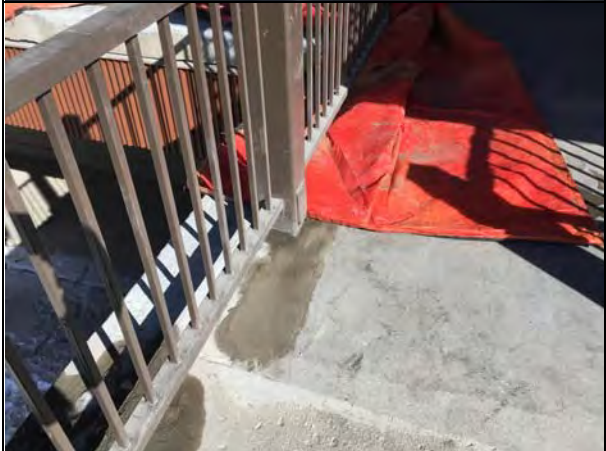
<p>10/31/19 – Photo 42 Axtell Building</p> <p>Spalled area has been repaired.</p>	Note

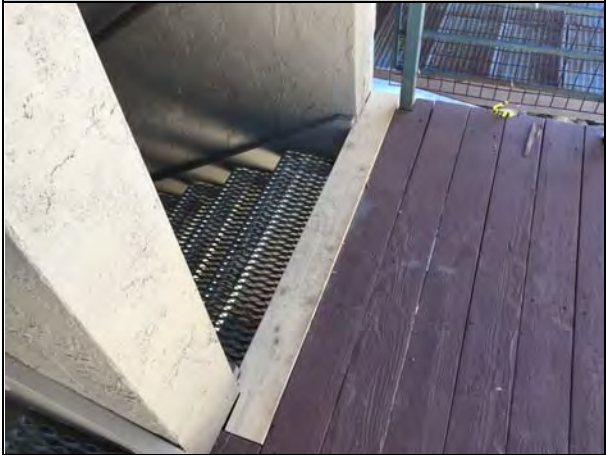
<p>10/31/19 – Photo 43 Axtell Building</p> <p>Stair nosing has been replaced, typical at each landing.</p> <p>Staining of the new wood will need to be done in the spring.</p>	Note

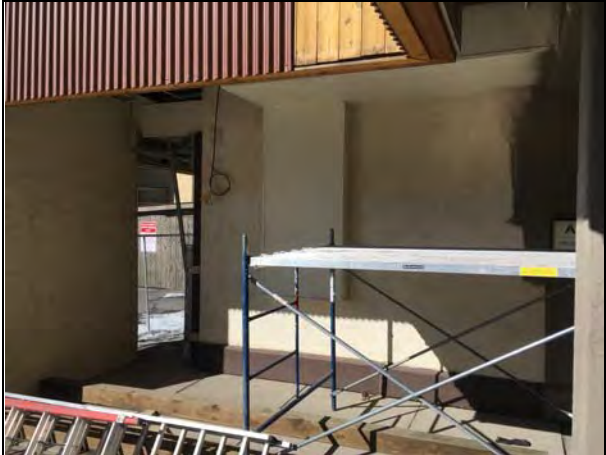
<p>10/31/19 – Photo 44 Axtell Building</p> <p>1<sup>st</sup> Floor west elevation, painting has not been completed in this area.</p>	Note
 	<p>10/31/19 – Photo 45 Axtell Building</p> <p>1<sup>st</sup> Floor west elevation, painting has not been completed in this area.</p>	Note

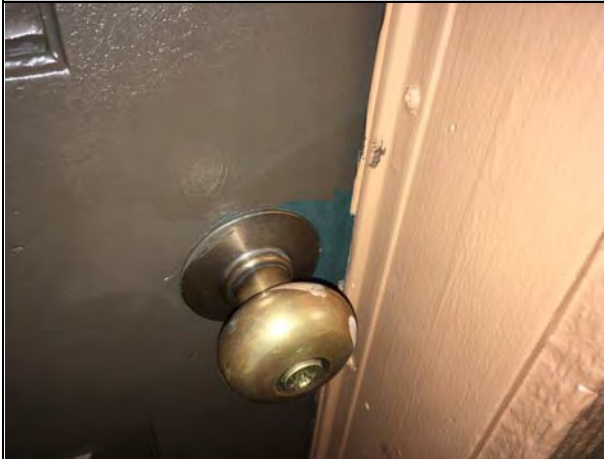
<p>10/31/19 – Photo 46 Axtell Building</p> <p>Unit 416 door perimeter has not been painted.</p>	Note

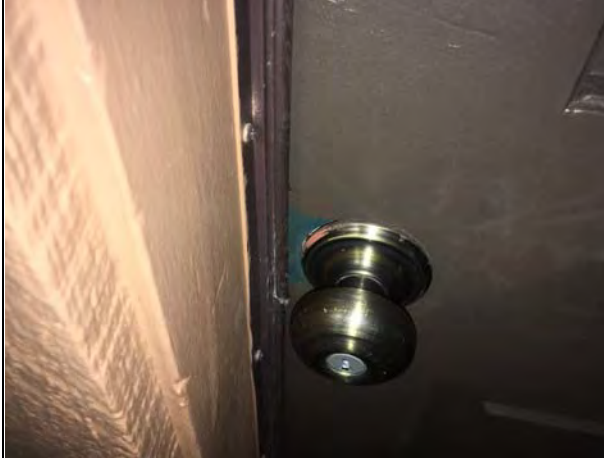
<p>10/31/19 – Photo 47 Axtell Building</p> <p>Unit 417 door perimeter has not been painted.</p>	Note

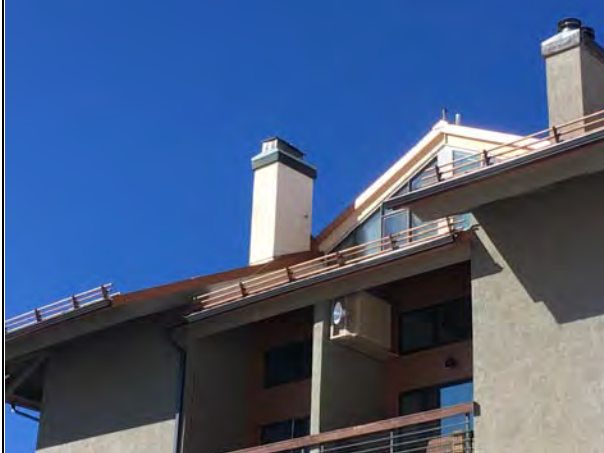
<p>10/31/19 – Photo 48 Axtell Building</p> <p>South chimney painting remains. AAS may subcontract work.</p>	AAS

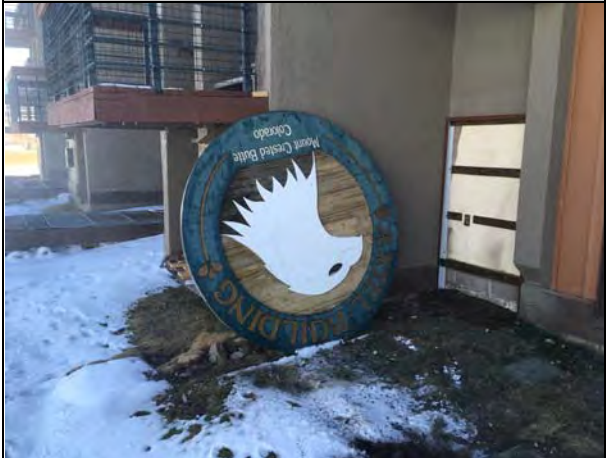
<p>10/31/19 – Photo 49 Axtell Building</p> <p>Building Sign on east elevation remains on site. HOA Board to provide direct:</p> <ol style="list-style-type: none"> <li>1.) Remove the sign</li> <li>2.) Store the sign</li> <li>3.) Reinstall the sign.</li> </ol>	HOA

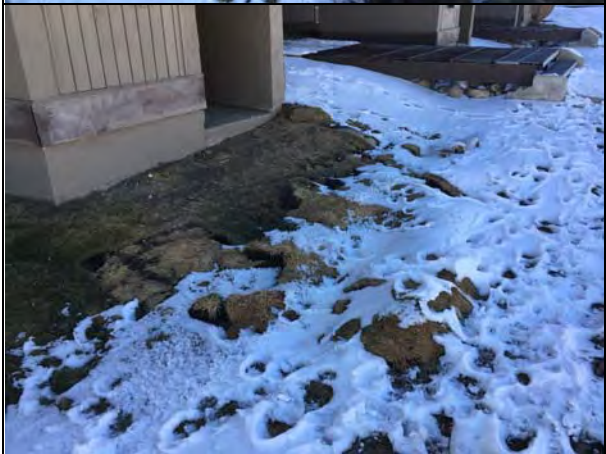
<p>10/31/19 – Photo 50 Axtell Building</p> <p>Ground disturbance to be returned to original condition, typical of 4 locations.</p>	PI

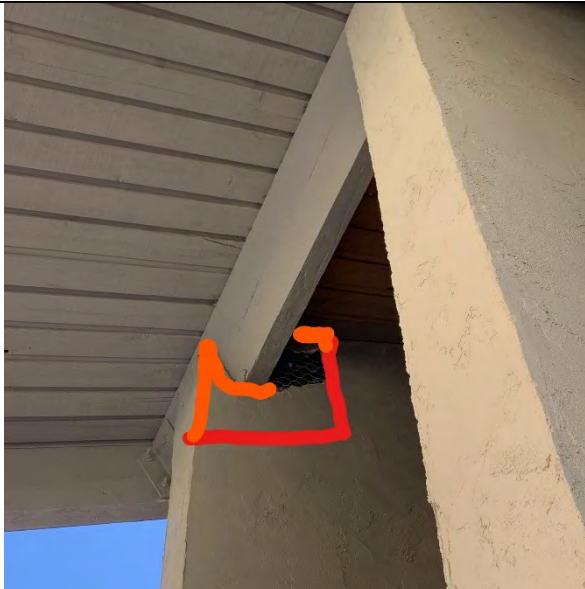
North Emmons beam bearing location requiring structural investigation. Stucco has been removed in a small location by beam. Area outlined in red must be stripped down to wood sheathing.	Selective demolition

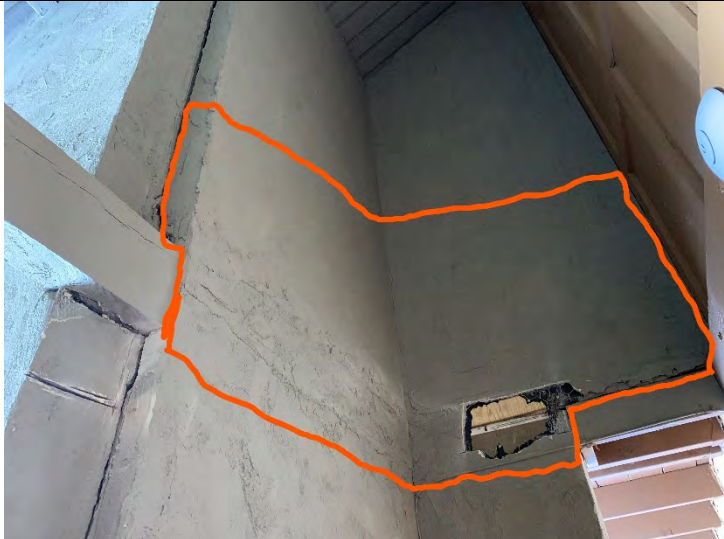
<p>North Emmons wall separation location requiring structural investigation. Stucco has been removed in a small location (bottom right of photo). Area outlined in red must be stripped down to wood sheathing.</p>	<p>Selective demolition</p>

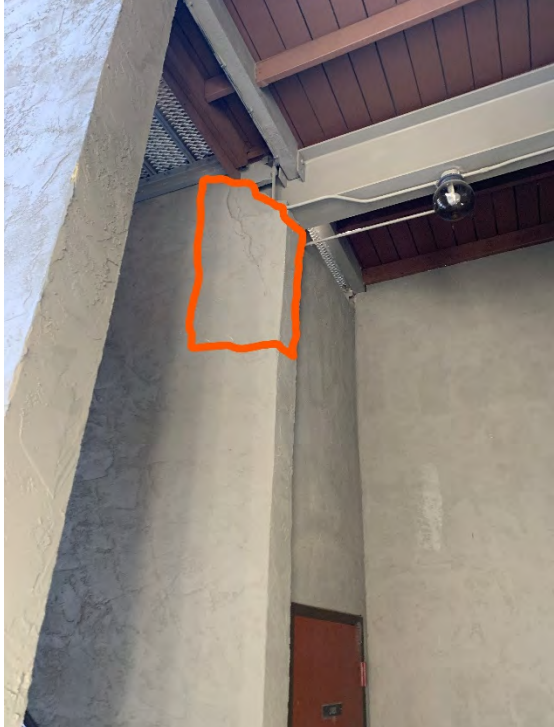
<p>South Emmons steel beam bearing location requiring structural investigation. No demolition has occurred to date. Area outlined in red must be stripped down to bare concrete.</p>	<p>Selective demolition</p>

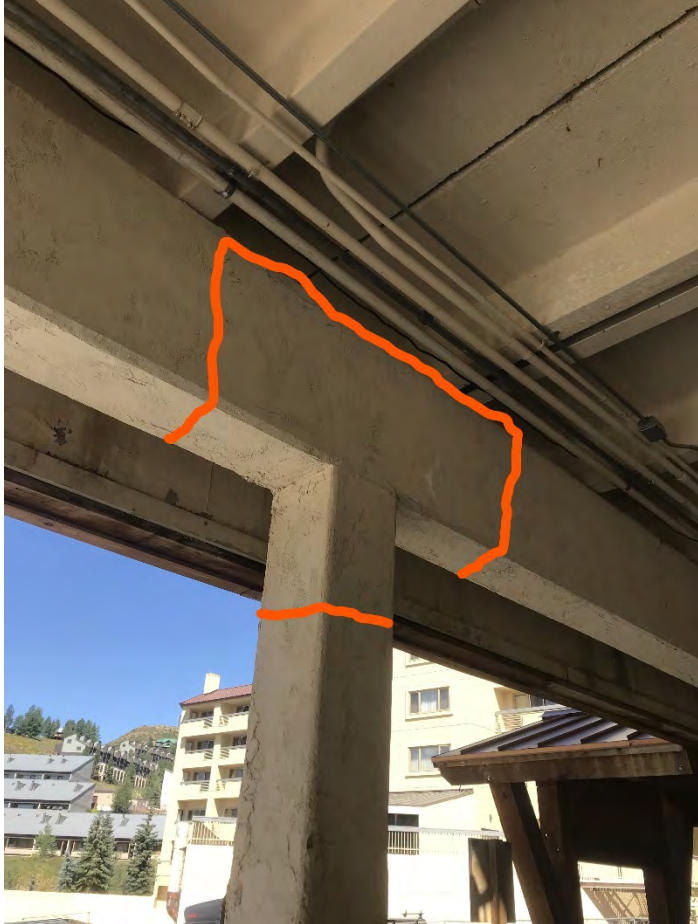
<p>Axtell plaza beam-column joint requiring structural investigation. No demolition has occurred to date. Area outlined in red must be stripped down to bare concrete. All four sides of column and three sides of beam (not required on top of beam).</p>	<p>Selective demolition</p>
--	--	-----------------------------
